CASE 4. CALCULATING WALL R-VALUES

Table 1 below summarizes the R-value calculations for each wall and their retrofit options. A photo summary of the retrofits follows.

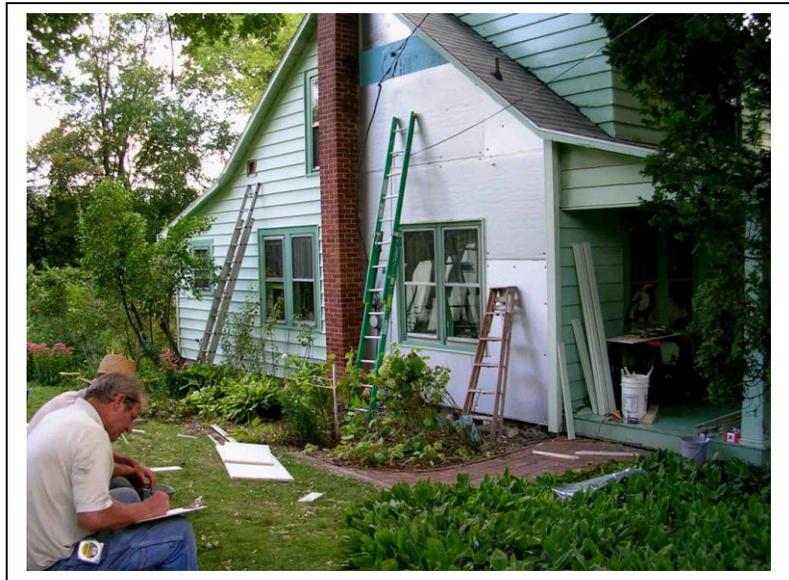
Right: Picture 1. East wall retrofit: adding two 1” layers of foamboard after removal of vinyl siding

East Wall. Examining the two alternatives, it was clear that we could get a better wall with less work and cost by taking off the vinyl siding (and saving it for re-installation) and adding two layers of 1" foamboard. Otherwise, we would have had to take the entire wall apart, vacuum up rock wool, itself a challenge, spray in urethane foam using another contractor, and replace the wall. Too much work for a limited gain.

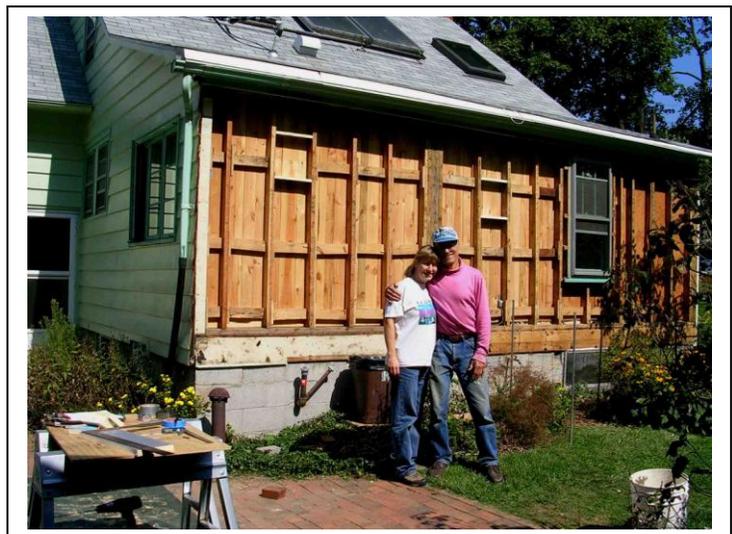
Right: Picture 3. South wall retrofit: Tania and Gene in front of wall cleaned down to studs, with holes for hot air collector vents framed

South Wall. Once we knew the insulation was fiberglass, we knew we wanted to take it out. The amount was inadequate to start with, and with age had pulled away from the studs, and become matted and riven by rodents. Fiberglass batting is no longer the insulation material of choice. Its performance declines at temperature extremes, either hot or cold. It can trap moisture, and is toxic. What remained for us was the choice between icynene and urethane. We went with the latter because it has a higher R value. Since we were rebuilding the wall, we decided to incorporate two hot air collectors as part of the south wall. Consequently, we were able to salvage enough of the old growth cedar siding to cover the remaining area outside the collector boxes.

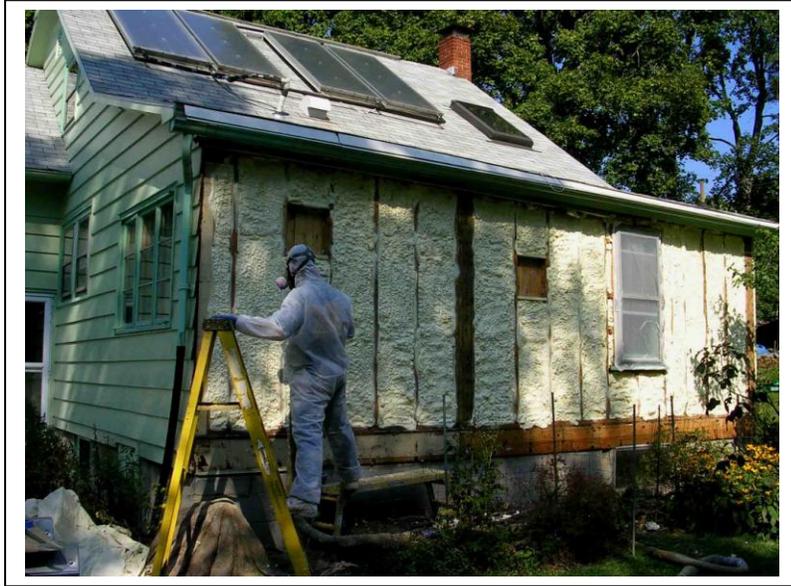
Left: Picture 4. Urethane foam being sprayed into stud cavities

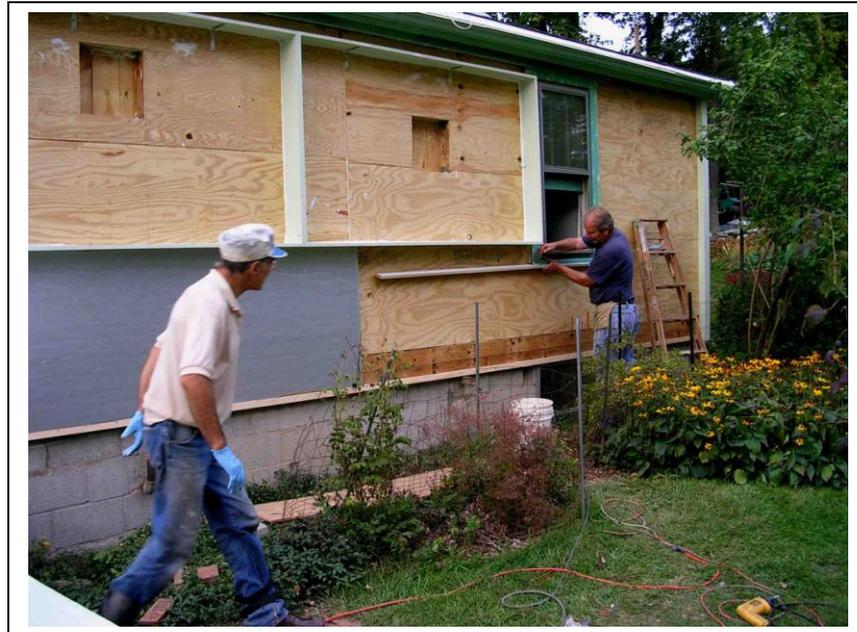
Above: Picture 5. Gene working with Howard Kephart, contractor. We nailed sheathing over foam-filled stud cavities, installed frames for hot air collectors, and are now nailing 1” foamboard. We will nail siding over this.
